**CADET MINE TAILINGS DAM
WASHINGTON COUNTY, MISSOURI
MO 30715**

PHASE 1 INSPECTION REPORT NATIONAL DAM SAFETY PROGRAM

FEBRUARY 1980

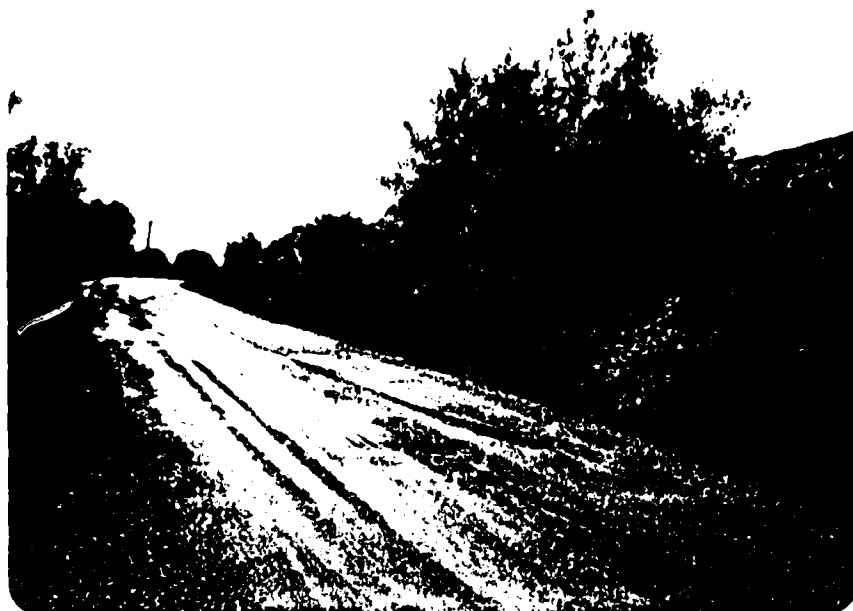
The embankment has encroached onto the paved road at the south end of the impoundment. The roadside drainage ditch has been blocked and runoff in this ditch could cause erosion of the embankment toe in this area.

7	Encroachment of the embankment fill onto the paved road adjacent to the south end of the impoundment near Station 6+00.
